# **PLAY AREA SAFETY INSPECTION REPORT**

**For Tattersett Parish Council**

On 27th January 2022

Play Area, Blenheim Road, Wicken Green, Norfolk

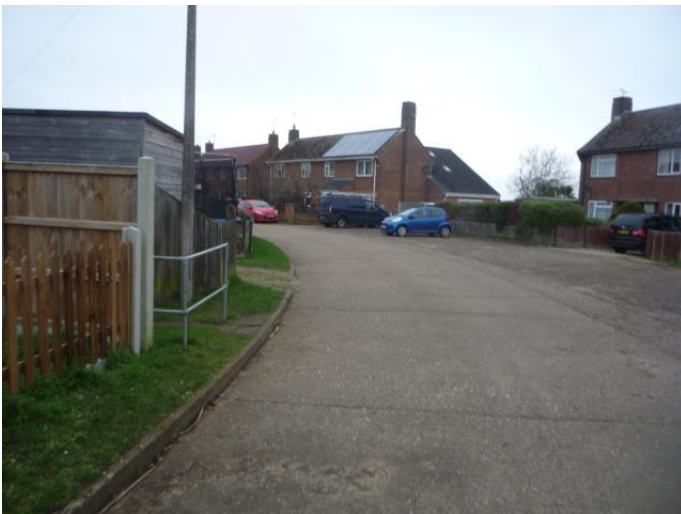
Where the play area is near a road the use of triangular warning road signs(two running children) to warn motorists of the presence of a playground should be considered. One sign is in place but the other access has no sign – Recommend add Road sign to cover this access.

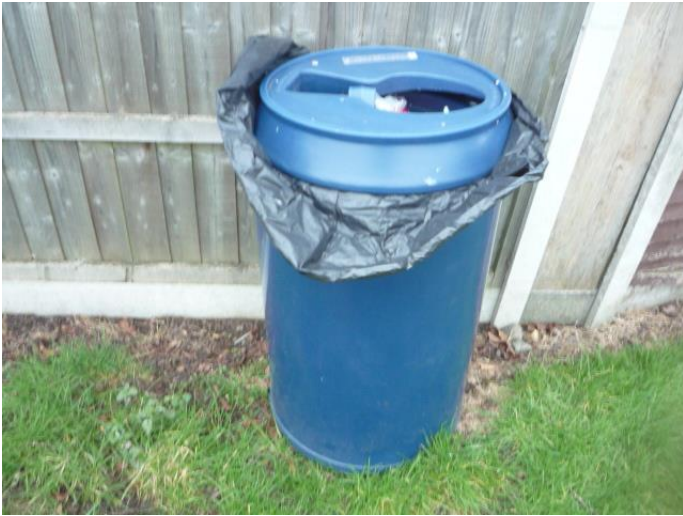
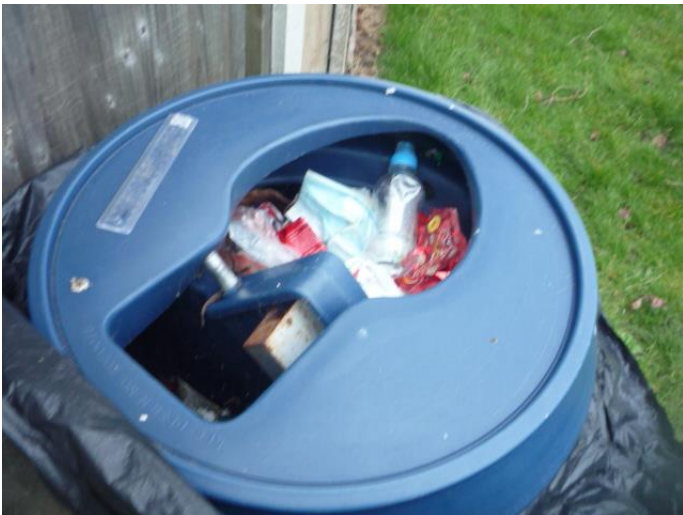
Litter Bin x 1 – Full – Recommend review emptying frequencies - Low risk.

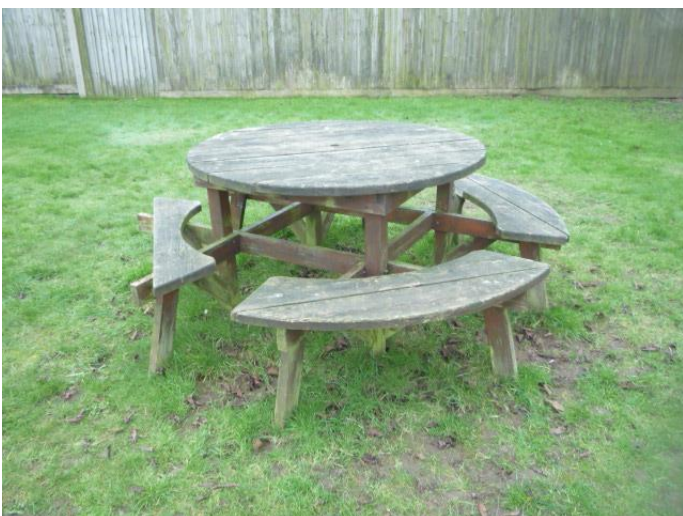
Picnic Bench – Recommend replace missing slat and smooth down damaged areas - Low to Medium risk.

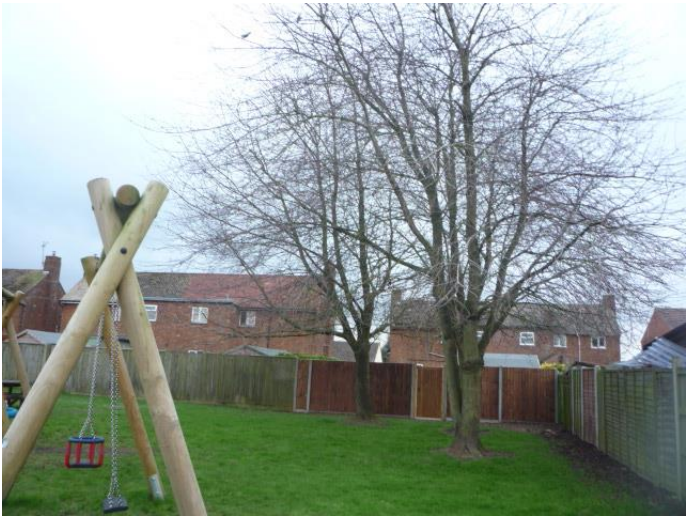
Mature trees in play area – Recommend to inspect annually by a qualified arboriculturist and to remove any dead, diseased and damaged wood. It is recommended not to use the play area in high winds.

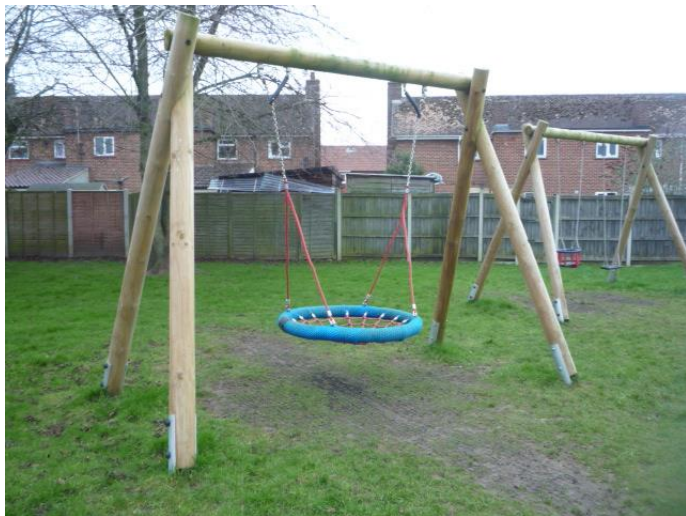
### **Item: Basket Swing (2600mm) - NGF**

The item meets the requirements of EN1176 where this may be tested on site without dismantling or destruction.

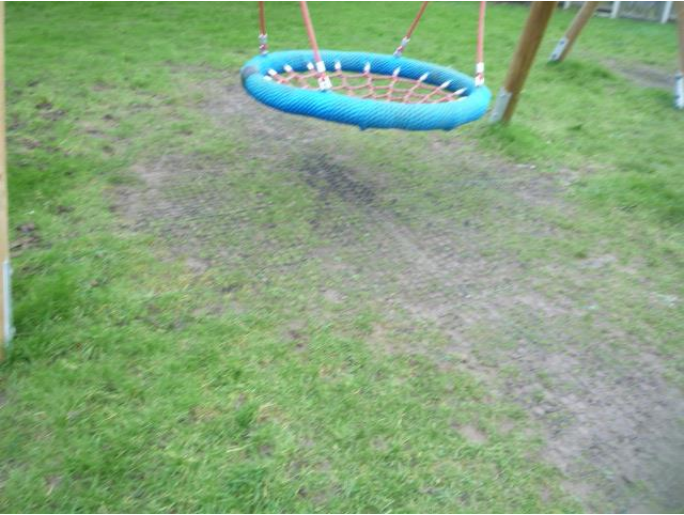
This type of safety surface should have grass present to provide adequate protection in user falls, as the grass roots absorb the impact of any falls. The surface therefore does not give the same protection as with grass and the risk of damage to users in falls is increased.

In the first instance it is recommended to raise the swing seats to 635mm (from safety surface to bottom of seat) and spread seed and soil mix over the worn area – if this fails to eliminate wear from dragging feet serious consideration should be given to replacing this surface with a non-wearing type of safety surface such as Bonded Rubber Crumb or Wet Pour – Low to Medium risk.

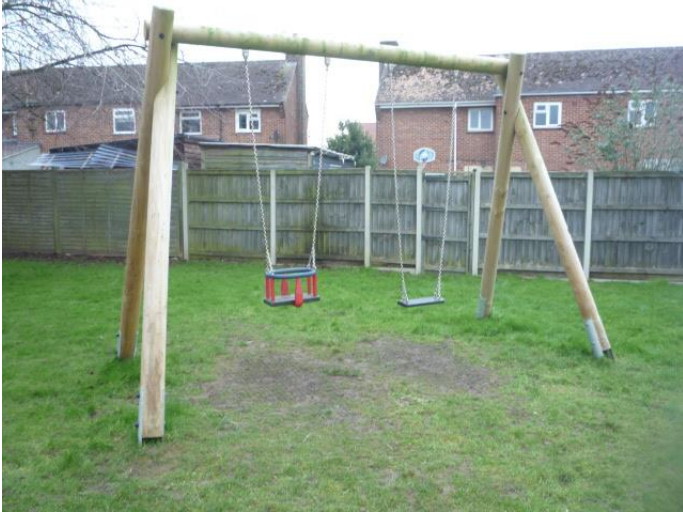
## **Item: 1 Bay 1 Flat/1 Cradle Seat Swing ( 2600mm) - NGF**

The item meets the requirements of EN1176 where this may be tested on site without dismantling or destruction.

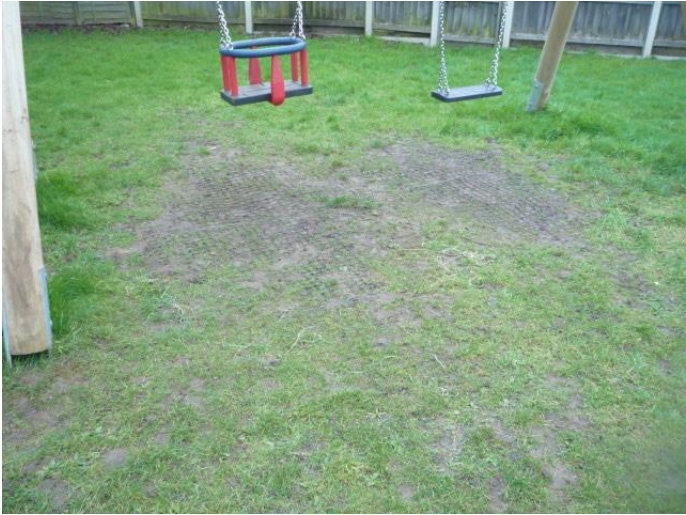
This type of safety surface should have grass present to provide adequate protection in user falls, as the grass roots absorb the impact of any falls. The surface therefore does not give the same protection as with grass and the risk of damage to users in falls is increased.

In the first instance it is recommended to raise the swing seats to 635mm (from safety surface to bottom of seat) and spread seed and soil mix over the worn area – if this fails to eliminate wear from dragging feet serious consideration should be given to replacing this surface with a non-wearing type of safety surface such as Bonded Rubber Crumb or Wet Pour – Low to Medium risk.

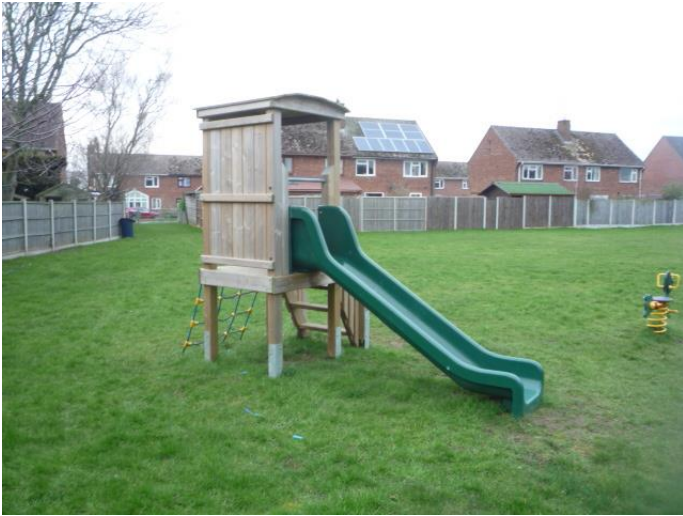
## **Item: Toddler Slide - NGF**

The item meets the requirements of EN1176 where this may be tested on site without dismantling or destruction.

The surfacing is in satisfactory condition and no work is required at this time.

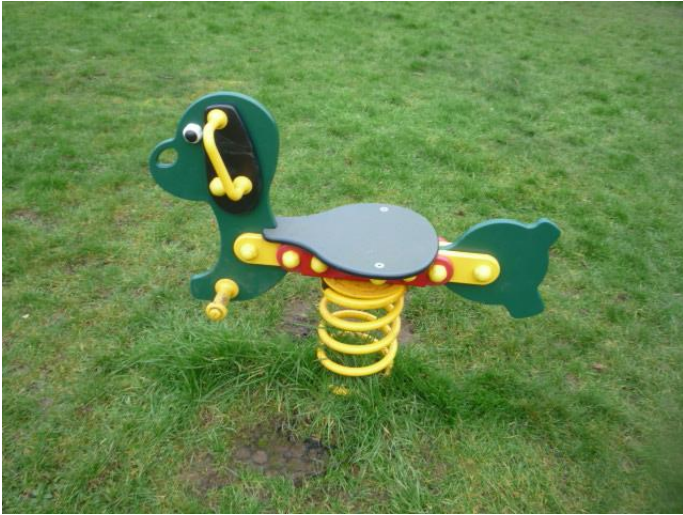
### **Item: Type 2a Rocker – Springy Dog - Fahr**

The item meets the requirements of EN1176 where this may be tested on site without dismantling or destruction.

The surfacing is in satisfactory condition and no work is required at this time.

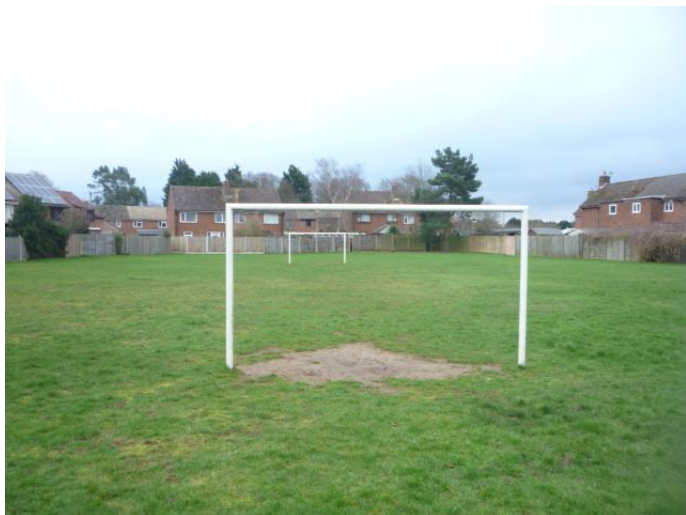
## **Item: Small Size Goals x 2**

The item meets the requirements of BS 8462:2005 + A1:2012 and BS 8461:2005 where this may be tested on site without dismantling or destruction.

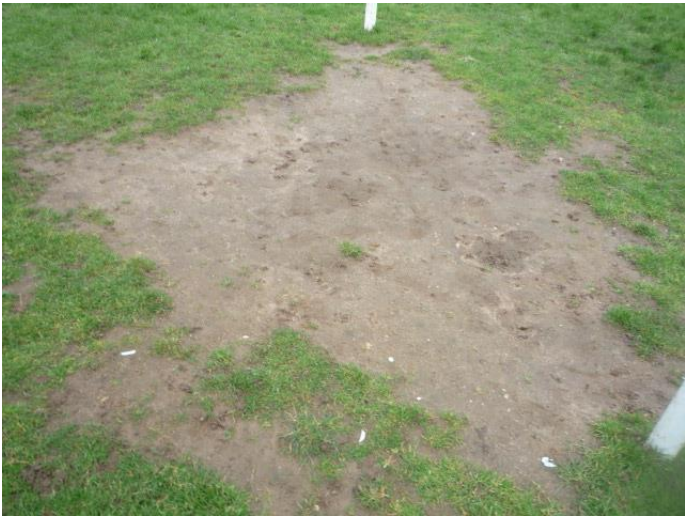
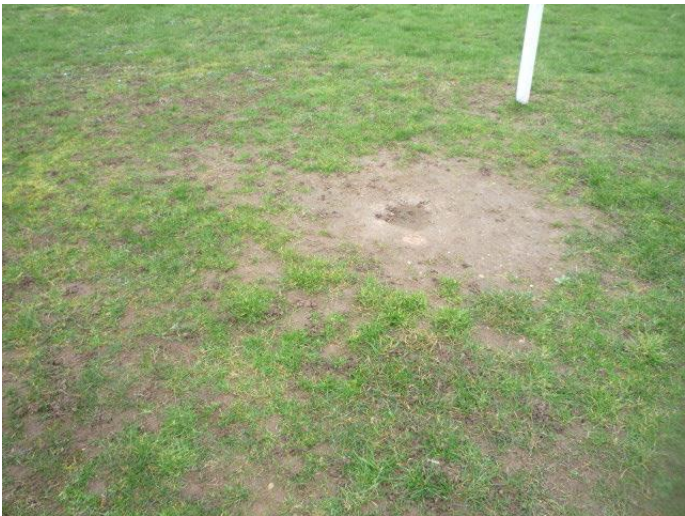
Recommend repair worn grass when conditions allow (or move goals periodically) – Low risk.
